# PEDESTRIAN EXISTING CONDITIONS

## PEDESTRIAN OVERVIEW

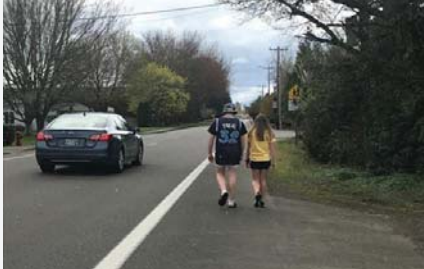
- Significant gaps in sidewalk connectivity
- Sidewalk is directly adjacent to the roadway except for a few buffered areas
- Majority of pedestrian ramps are not ADA compliant
- Lack of street lighting for pedestrian crossing visibility

PEDESTRIANS WALKING ON ROAD SHOULDER

- Fill in sidewalk gaps
- Rebuild pedestrian ramps
- Add street lighting
- Install Pedestrian Crossing Enhancements (warning signage, pedestrian medians, crosswalks, push button activated flashers, etc.)

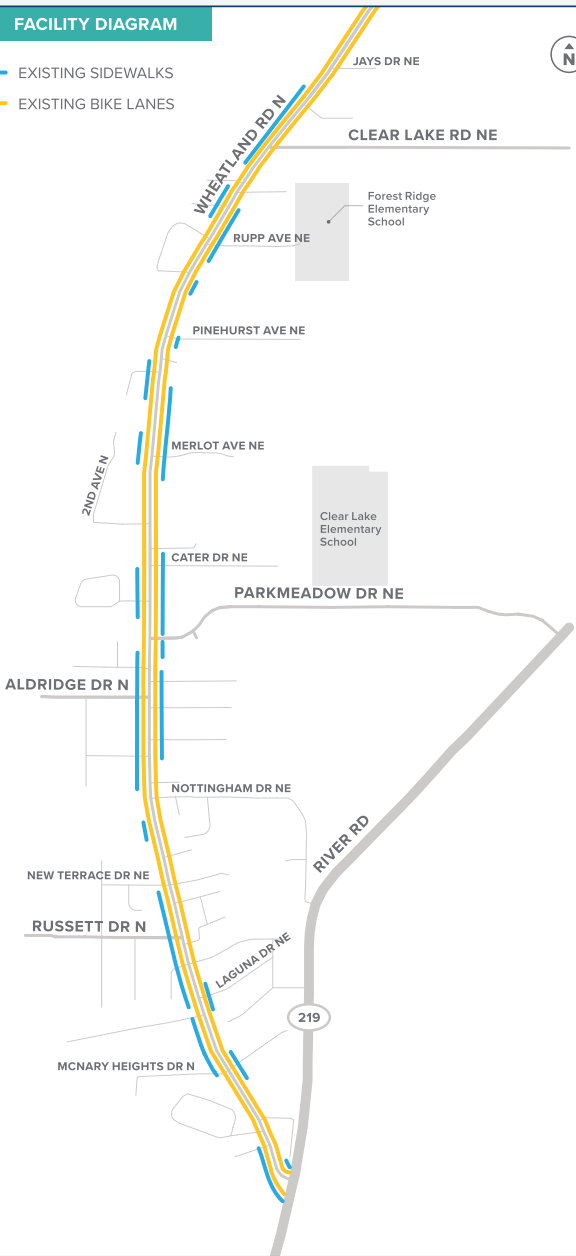
## FACILITY DIAGRAM

- EXISTING SIDEWALKS
- EXISTING BIKE LANES

- **Segments**
  - » River Rd → Laguna Dr: **POOR**
  - » Laguna Dr → Parkmeadow: **POOR**
  - » Parkmeadow Dr → 2nd Ave: **POOR**
  - » 2nd Ave → Jays Dr: **POOR**
- **Intersections**
  - » River Rd: **GOOD**
  - » Russett Dr: **POOR**
  - » Aldridge Dr: **FAIR**
  - » Parkmeadow Dr: **POOR**
  - » Clear Lake Rd: **POOR**
