EXISTING CONDITIONS OVERVIEW

OVERVIEW

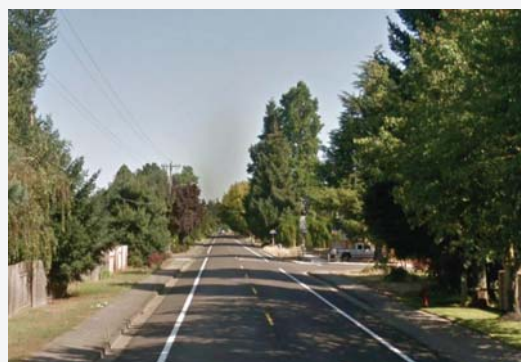
- Consistent 2-lane, 2-way vehicle roadway (12 ft average lane widths)
- Consistent bicycle lanes on each side (6 ft average lane widths)
- Interspersed pockets of sidewalks that:
 - » Creates connectivity issues
 - » Are usually not buffered with a planter strip

ROADWAY CROSS-SECTION WITH SIDEWALKS ON BOTH SIDES¹

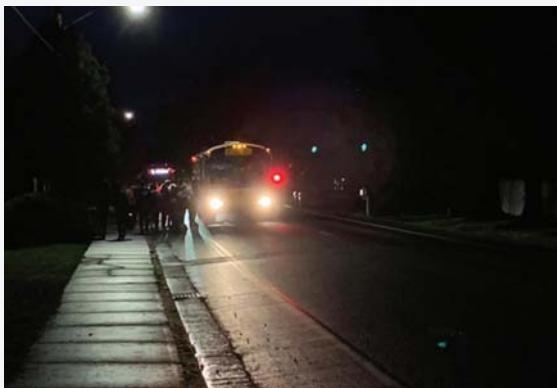
DARK CONDITIONS AT A SCHOOL BUS STOP

- Inadequate lighting for entire corridor
- Poor uniformity of street lighting (bright and dark areas) which impacts driver visibility
- Visibility is especially challenging at several of the school bus stops

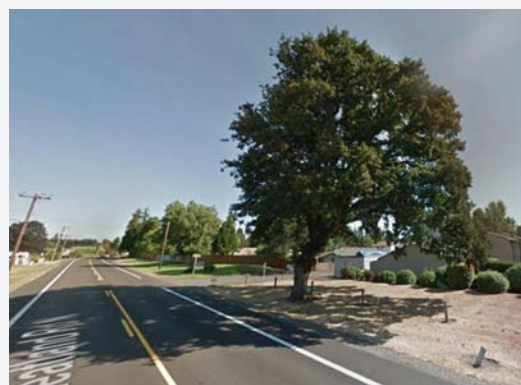
- Presence of Mature Trees:
 - » Desire to protect the trees where feasible
- No designated wetlands exist within the project corridor
- New stormwater features and landscaping opportunities will be considered in the concept design

MATURE OAK TREES ADJACENT TO ROADWAY¹
