**PRELIMINARY DRAINAGE REPORT
FOR**

**1141 Chemawa Road
Keizer, Oregon**

**Prepared For:
Backus Investments, LLC
2415 Perkins Street
Salem, Oregon 97302**

June 30, 2023

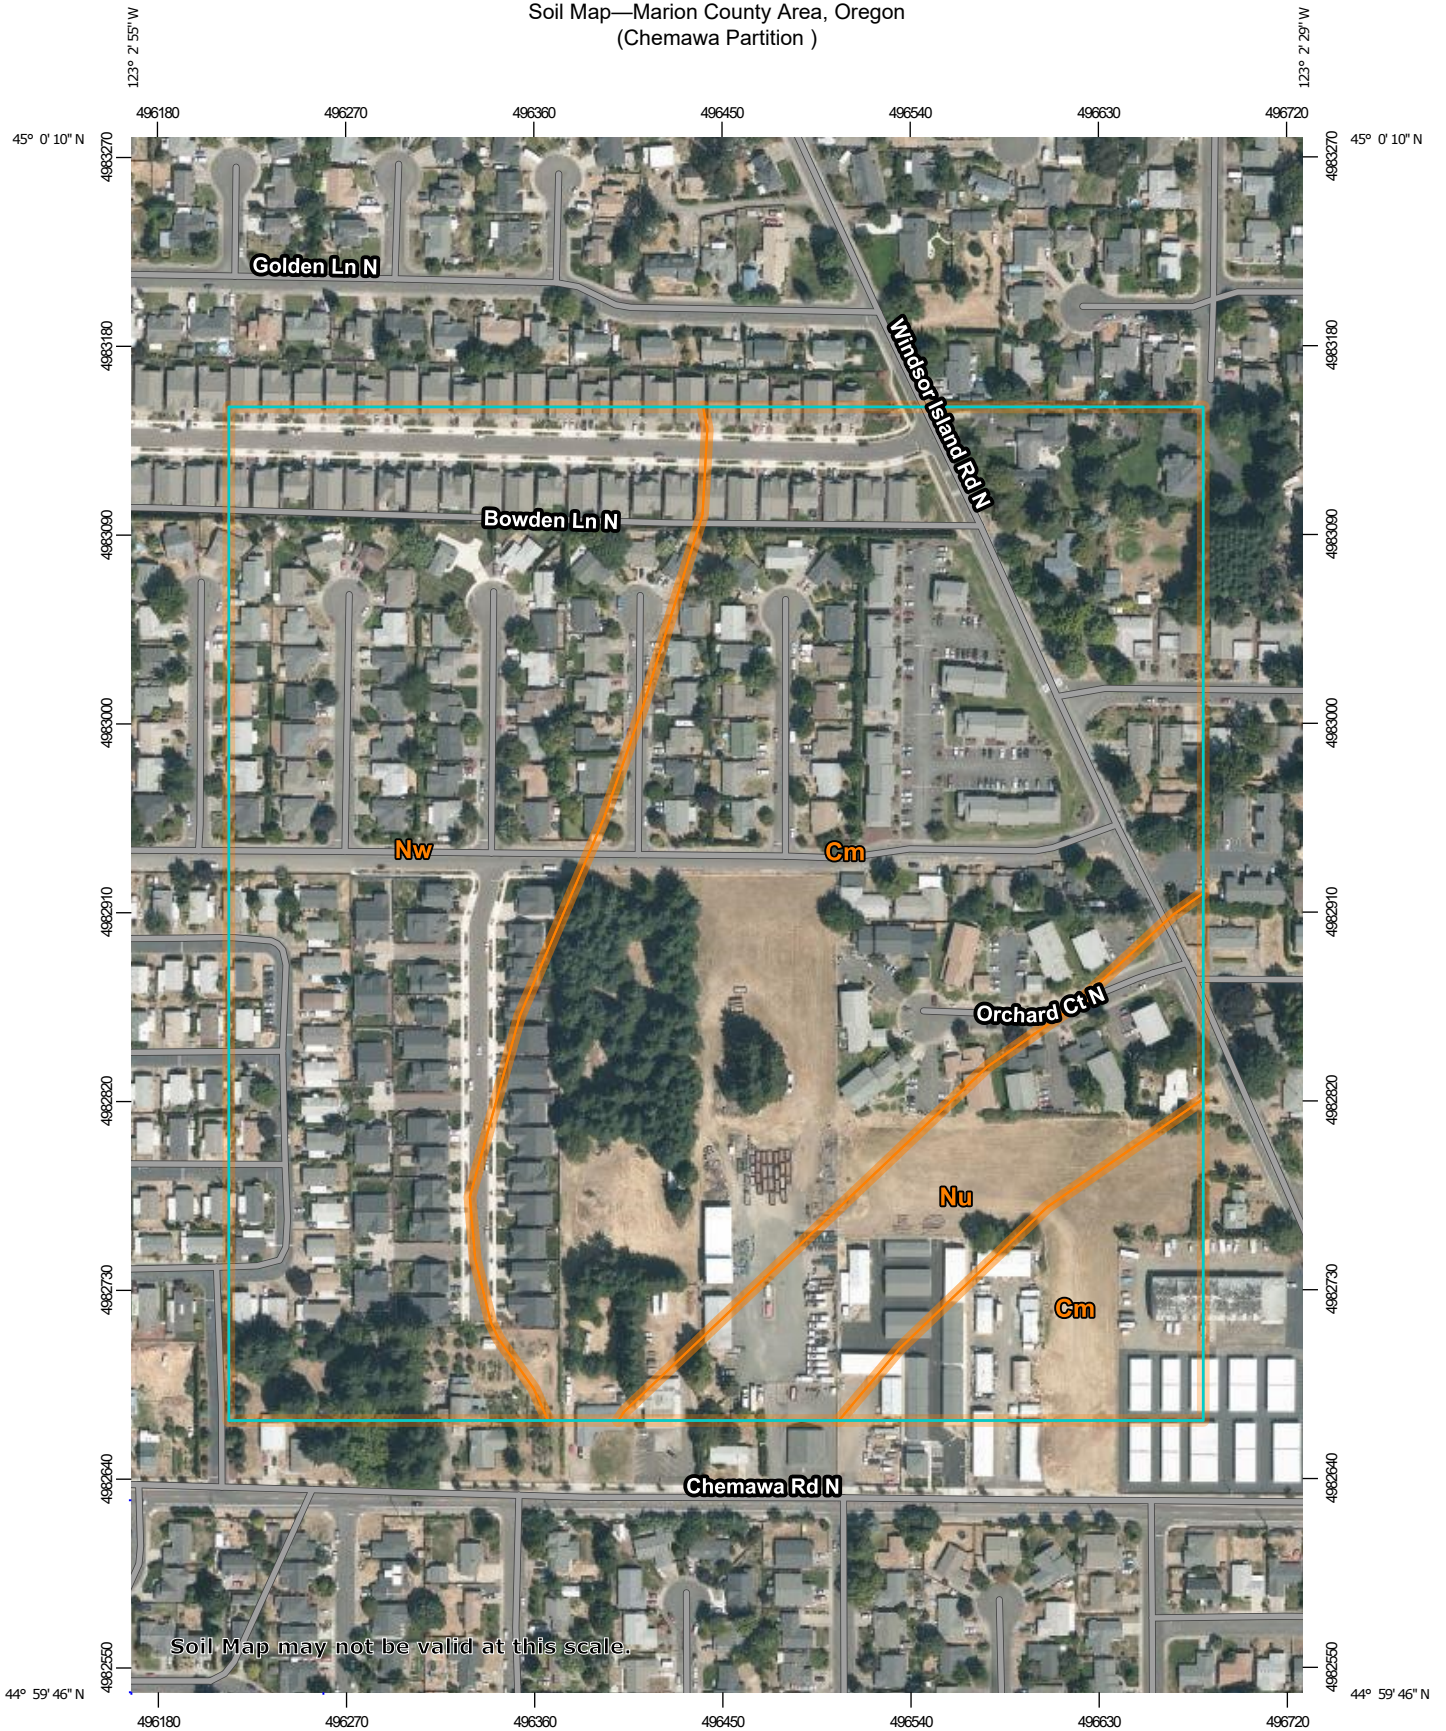
Soil Map—Marion County Area, Oregon
(Chemawa Partition)

Map Scale: 1:3,610 if printed on A portrait (8.5" x 11") sheet.

The Soil Conservation Service Soil Survey of Marion County identifies the predominate soils on the site as a Cloquato silt loam (map unit Cm). The soil is in the hydrologic soil group B. Appendix B contains the NRCS soil survey for the site.

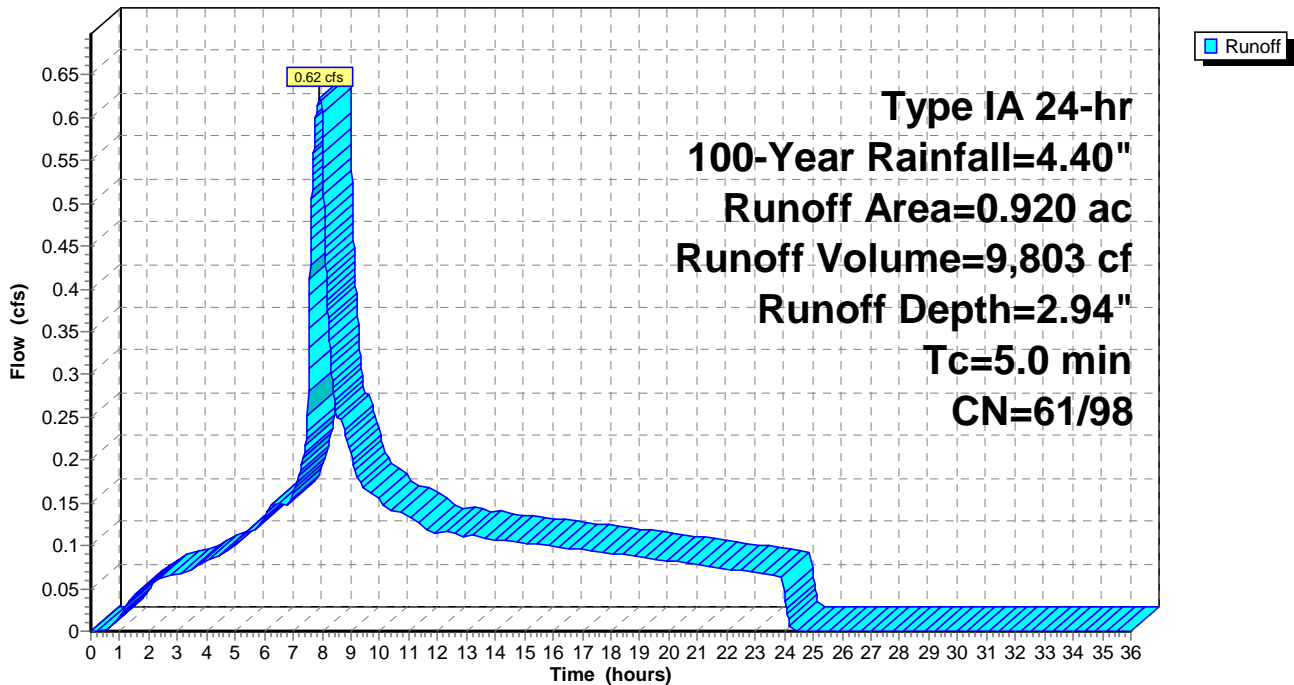
Hydrograph

Subcatchment Site: Apartments

Type IA 24-hr 100-Year Rainfall=4.40"

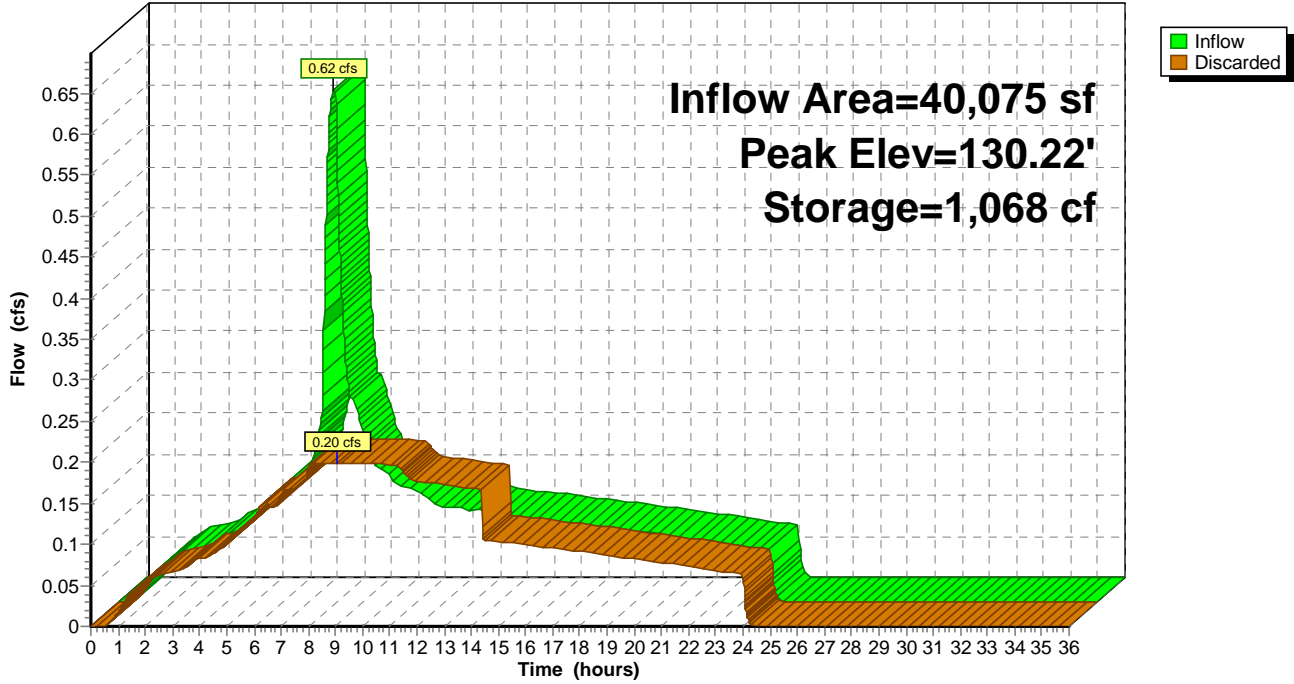
Hydrograph

Pond C: Combination Facility

Stormwater quantity within the site is proposed to be handled via a 40' X 40' X 3' combinations facility. Runoff will be routed to the facility that stores and infiltrates runoff for all storm events that includes the 100-year event. An infiltration rate of 4.5 inches per hour was used in the analysis.
