# STORMWATER MANAGEMENT REPORT

# 931 CHEMAWA ROAD NORTH PARTITION

**KEIZER, OR 97303**

SUBMITTED MAY 27, 2025

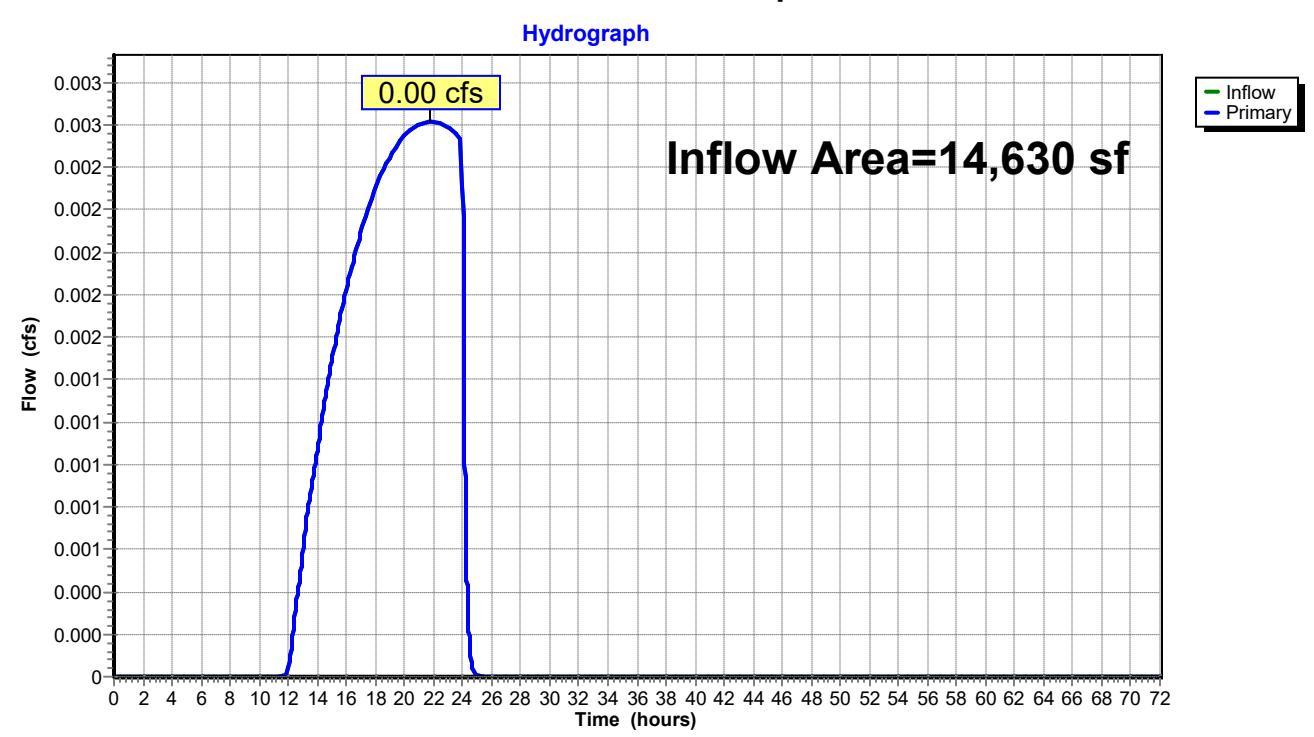
Inflow A	rea =	14,630 sf, 0.00% Impervious,	Inflow Depth = 0.07" for 2 yr event	
Inflow	=	0.00 cfs @ 21.76 hrs, Volume=	86 cf	
Primary	=	0.00 cfs @ 21.76 hrs, Volume=	86 cf, Atten= 0%, Lag= 0.0 mi	in

Primary outflow = Inflow, Time Span= 0.00-72.00 hrs, dt= 0.01 hrs

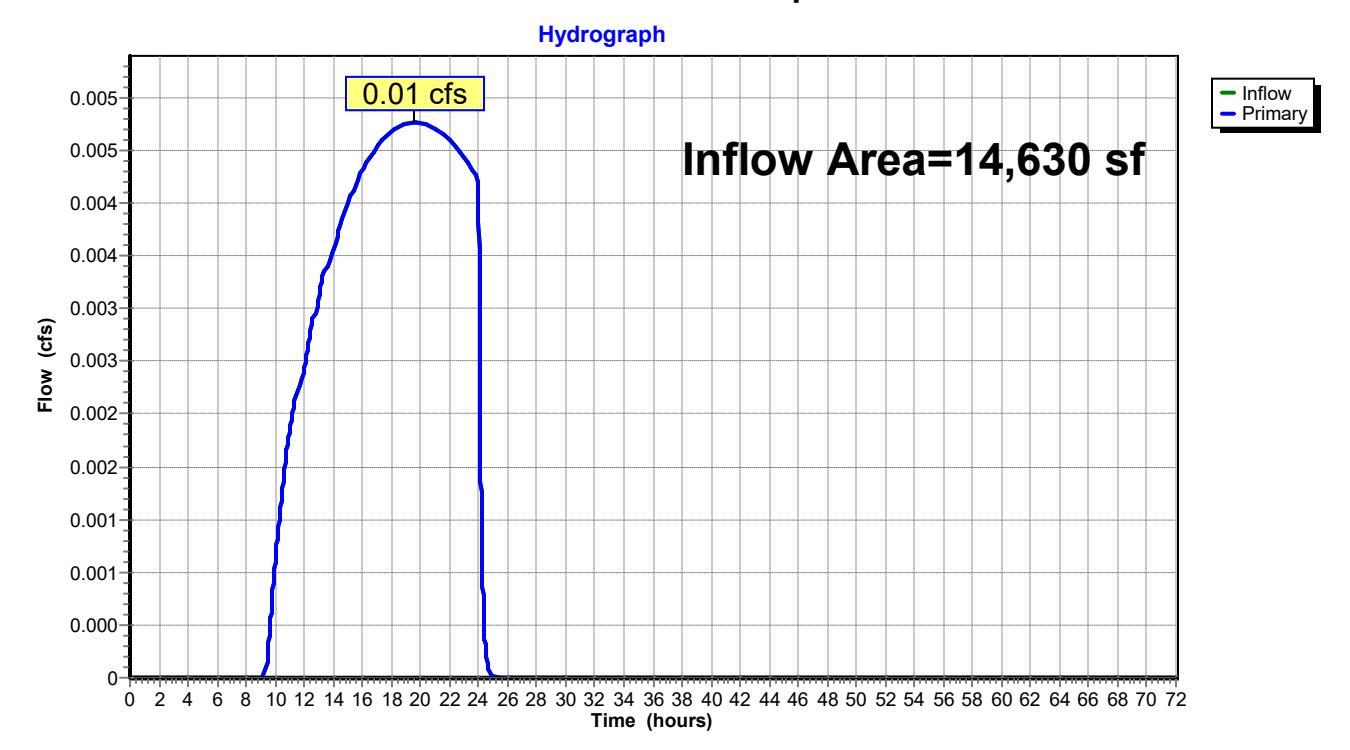
Inflow Area	a =	14,630 sf,	0.00% Im	pervious,	Inflow Depth =	0.18"	for 5 yr event
Inflow	=	0.01 cfs @	19.58 hrs, `	Volume=	225 c	f	
Primary	=	0.01 cfs @	19.58 hrs, `	Volume=	225 c	f, Atten	= 0%, Lag= 0.0 min

Primary outflow = Inflow, Time Span= 0.00-72.00 hrs, dt= 0.01 hrs

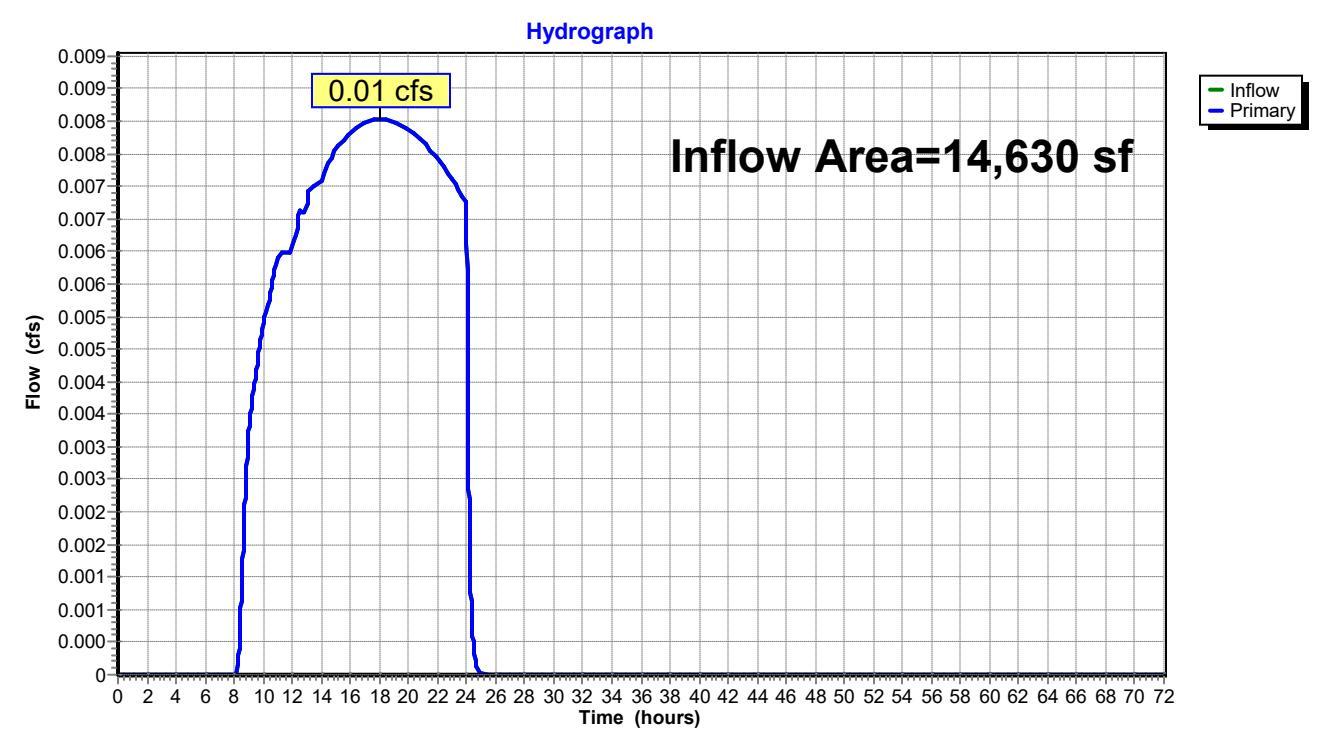
Inflow Area	a =	14,630 sf,	0.00% Imperv	vious, Inf	flow Depth =	0.34"	for 10 yr event
Inflow	=	0.01 cfs @	18.06 hrs, Volu	ume=	416 cf		
Primary	=	0.01 cfs @	18.06 hrs, Volu	ume=	416 cf	, Atten=	= 0%, Lag= 0.0 min

Primary outflow = Inflow, Time Span= 0.00-72.00 hrs, dt= 0.01 hrs

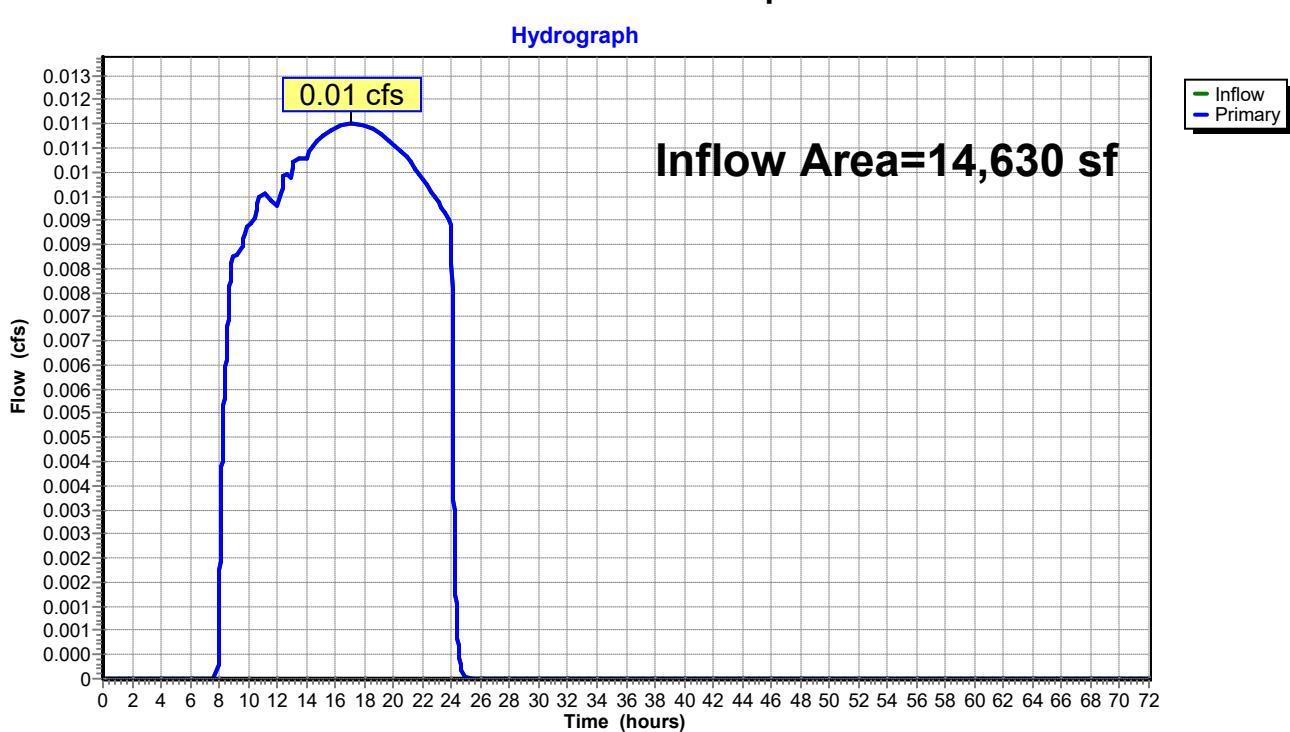
Inflow Are	a =	14,630 sf,	0.00% Im	pervious,	Inflow Depth =	0.49"	for 25 yr event
Inflow	=	0.01 cfs @ 1	17.12 hrs,	Volume=	601 c	f	
Primary	=	0.01 cfs @ 1	17.12 hrs,	Volume=	601 c	f, Atten	= 0%, Lag= 0.0 min

Primary outflow = Inflow, Time Span= 0.00-72.00 hrs, dt= 0.01 hrs

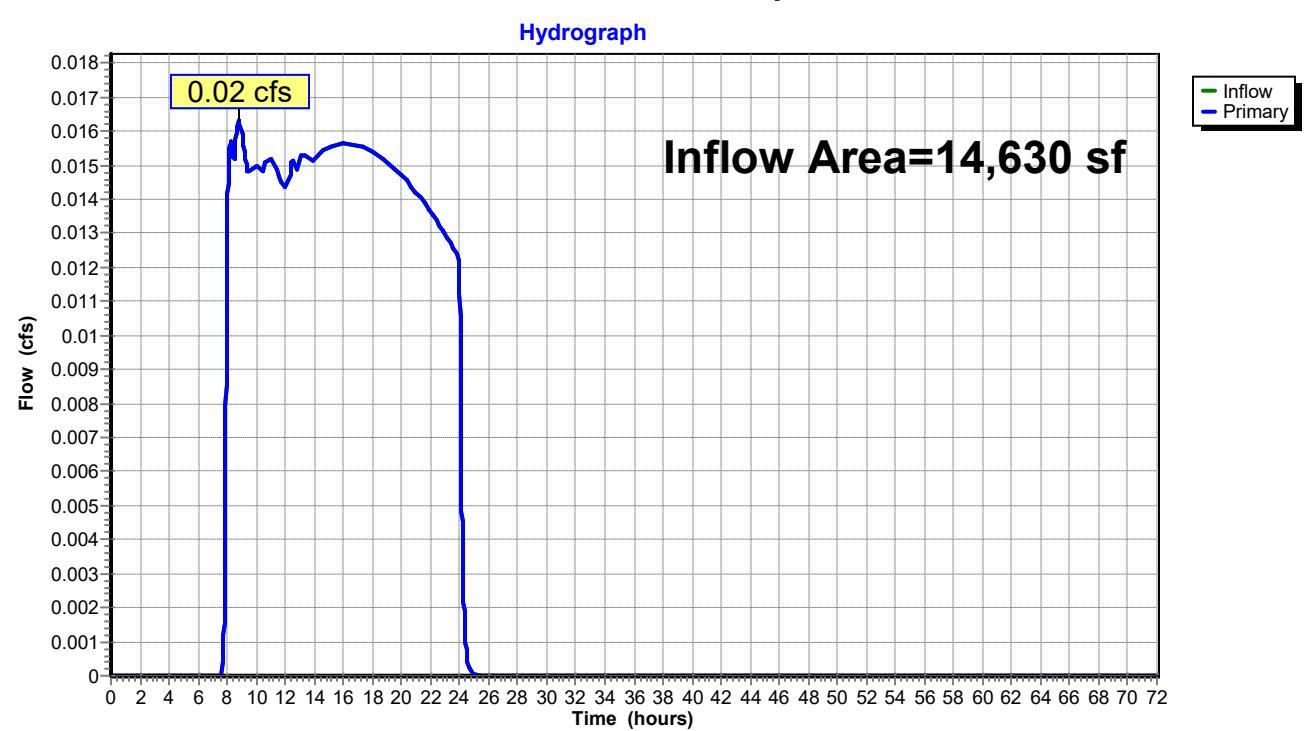
Inflow A	rea =	14,630 sf,	0.00% Impervious,	Inflow Depth = 0.71"	for 50 yr event
Inflow	=	0.02 cfs @	8.81 hrs, Volume=	867 cf	
Primary	- =	0.02 cfs @	8.81 hrs, Volume=	867 cf, Atte	n= 0%, Lag= 0.0 min

Primary outflow = Inflow, Time Span= 0.00-72.00 hrs, dt= 0.01 hrs

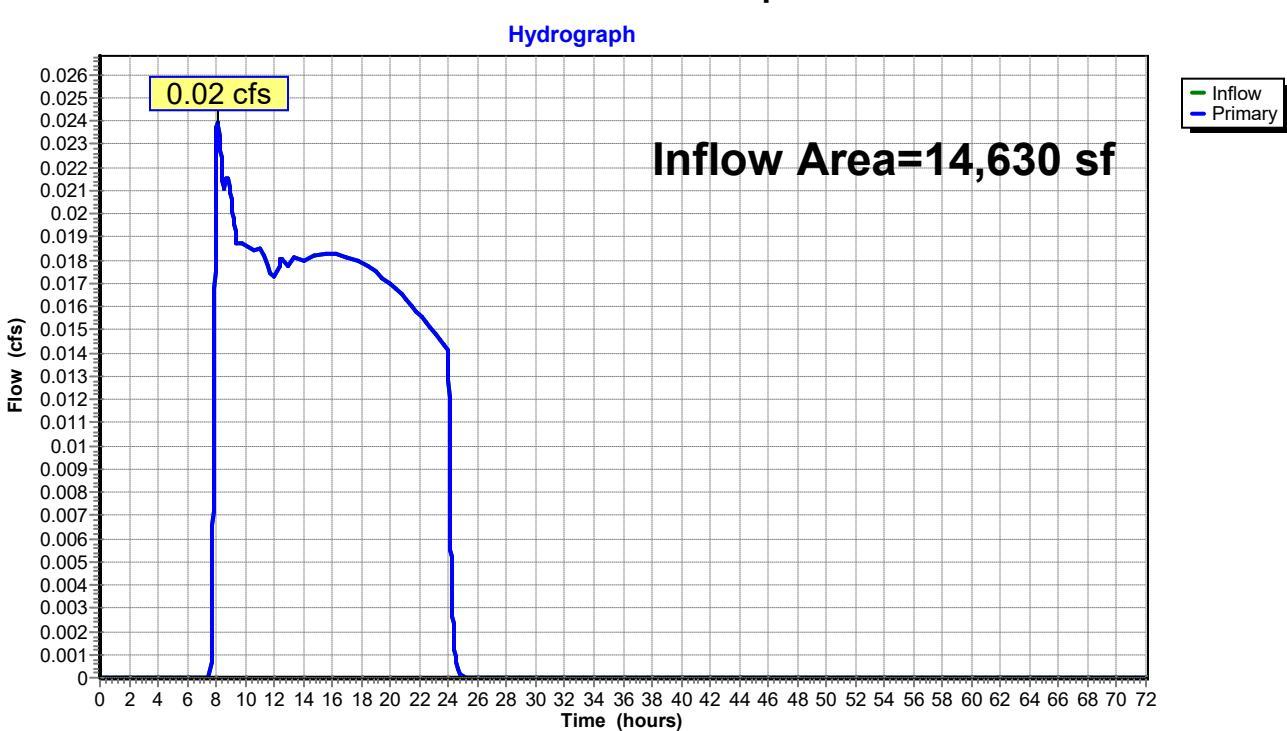
Inflow Are	ea =	14,630 sf,	0.00% Impervious,	Inflow Depth = 0.85"	for 100 yr event
Inflow	=	0.02 cfs @	8.12 hrs, Volume=	1,042 cf	
Primary	=	0.02 cfs @	8.12 hrs, Volume=	1,042 cf, Atter	n= 0%, Lag= 0.0 min

Primary outflow = Inflow, Time Span= 0.00-72.00 hrs, dt= 0.01 hrs

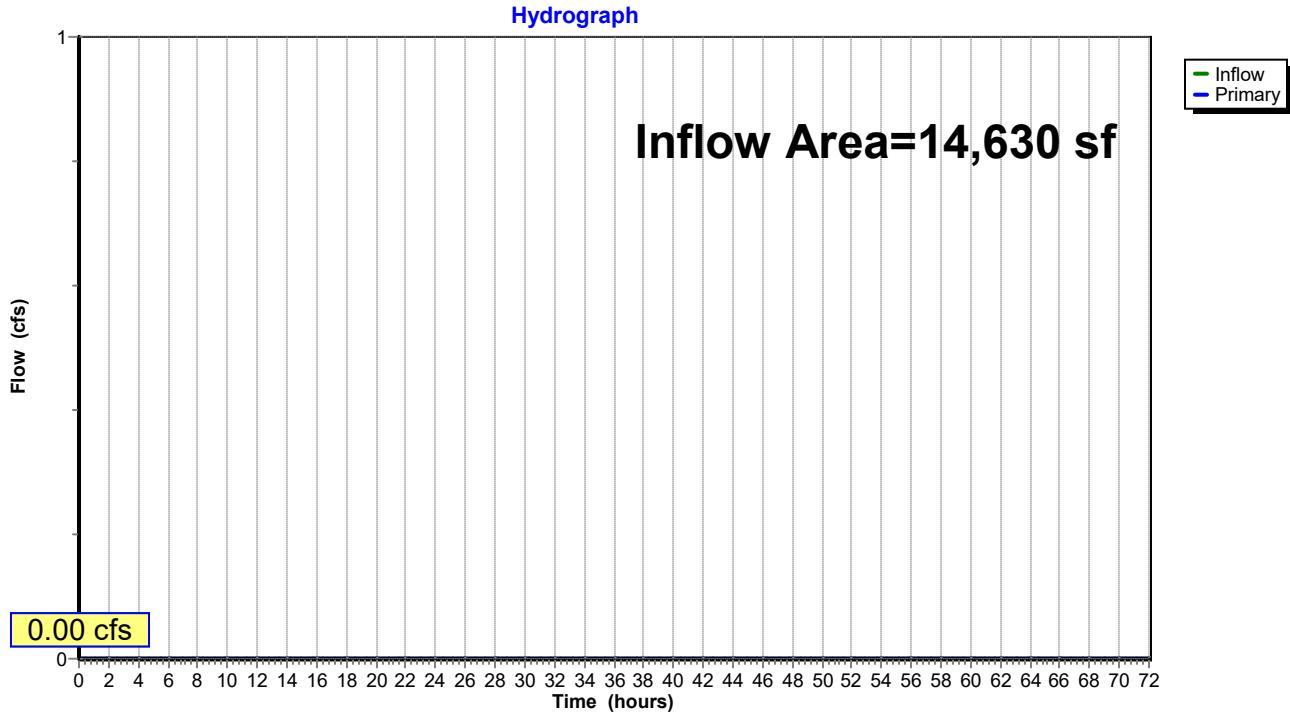
#### Link PRE: Pre Development

Inflow A	rea =	14,630 sf,	0.00% Impervious,	Inflow Depth = 0.00"	for WQ event
Inflow	=	0.00 cfs @	0.00 hrs, Volume=	0 cf	
Primary		0.00 cfs @	0.00 hrs, Volume=	0 cf, Atter	n= 0%, Lag= 0.0 min

Primary outflow = Inflow, Time Span= 0.00-72.00 hrs, dt= 0.01 hrs
